The Road Inventory of Conboy Lake National Wildlife Refuge Glenwood, WA

Prepared By:
Federal Highway Administration
Central Federal Lands Highway Division
April 2013

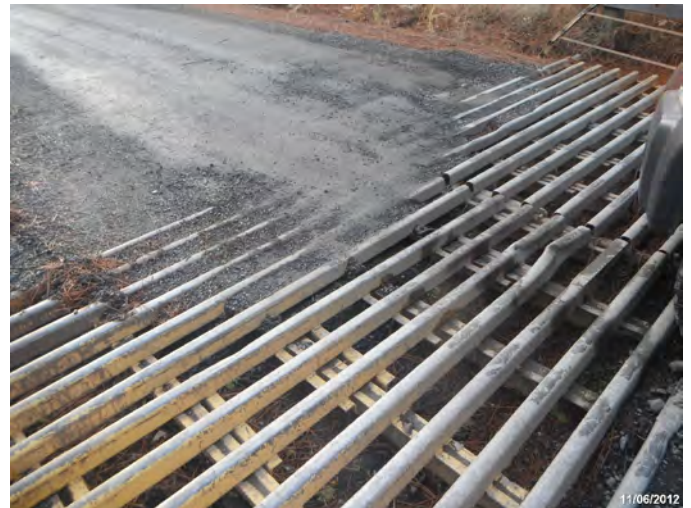
Photo: COLA_C4_0431 Route: 010-001-0.0
Begin Section

Photo: COLA_C4_0433 Route: 010-001-0.0
Metal Cattle Guard
Asset# NA

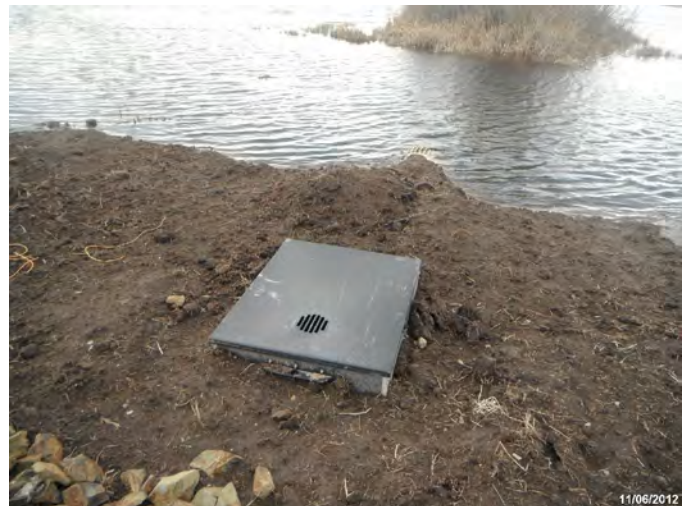
Photo: COLA_C4_0560 Route: 100-001-0.61
Metal WCS Flap Gate/Full-Round Riser 40ft long 36in dia.
1ft deep Asset# NA

Photo: COLA_C4_0561 Route: 100-001-0.61
Metal WCS Flap Gate/Full-Round Riser 40ft long 36in dia.
1ft deep Asset# NA

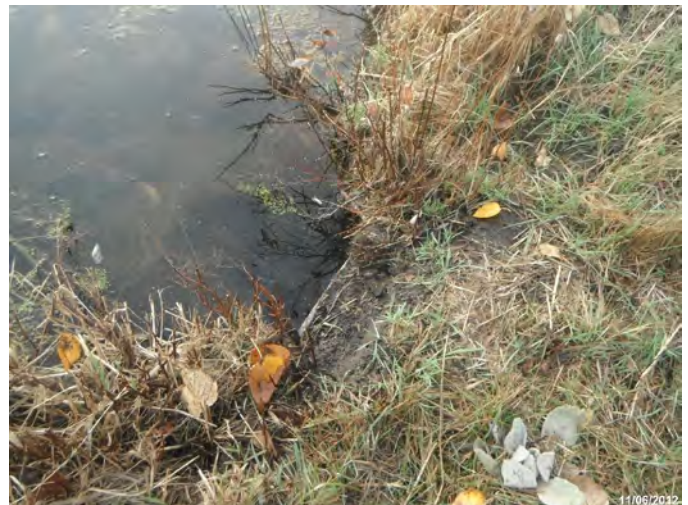
Photo: COLA_C4_0439 Route: 400-002-0.3
Metal WCS Flashboard Riser 30ft long 24in dia. 1ft deep
Asset# NA

Photo: COLA_C4_0440 Route: 400-002-0.3
Metal WCS Flashboard Riser 30ft long 24in dia. 1ft deep
Asset# NA 8-005

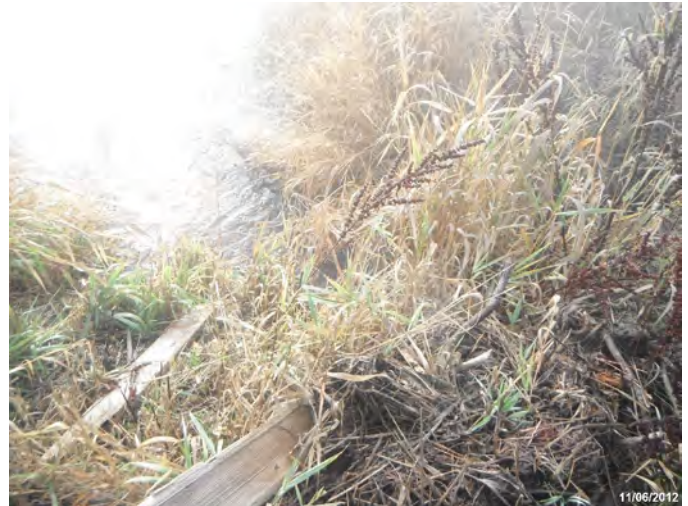
Photo: COLA_C4_0441 Route: 400-002-0.73
Metal WCS Flashboard Riser 30ft long 24in dia. 1ft deep
Asset# NA

Photo: COLA_C4_0442 Route: 400-002-0.73
Metal WCS Flashboard Riser 30ft long 24in dia. 1ft deep
Asset# NA

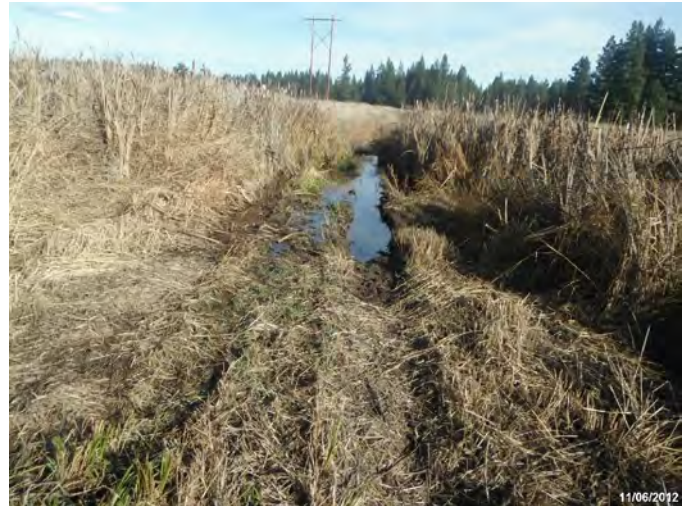
Photo: COLA_C4_0482 Route: 402-001-0.0
Problem Area Route underwater at this point

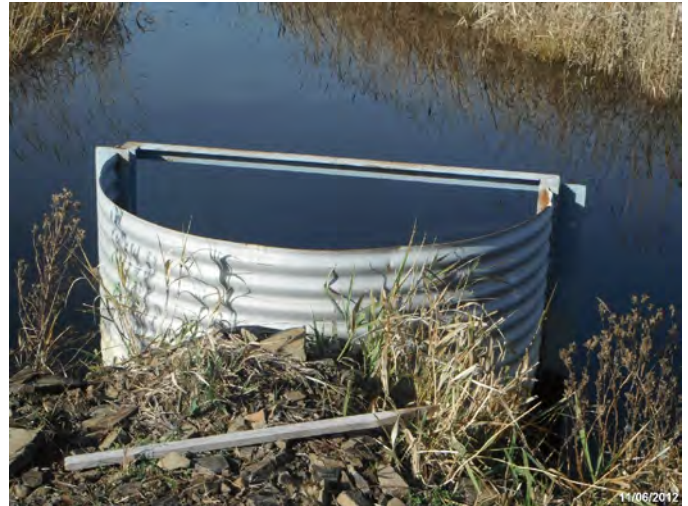
Photo: COLA_C4_0488 Route: 402-001-0.98
Metal WCS Flashboard Riser 40ft long 48in dia. 3ft deep
Asset# NA

Photo: COLA_C4_0489 Route: 402-001-0.98
Metal WCS Flashboard Riser 40ft long 48in dia. 3ft deep
Asset# NA

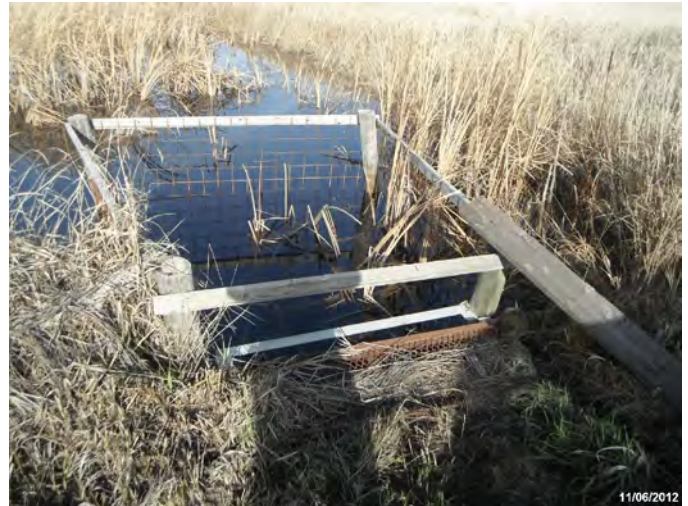
Photo: COLA_C4_0503 Route: 402-003-2.59
Metal WCS Flashboard Riser 30ft long 48in dia. 3ft deep
Asset# NA

Photo: COLA_C4_0504 Route: 402-003-2.59
Metal WCS Flashboard Riser 30ft long 48in dia. 3ft deep
Asset# NA

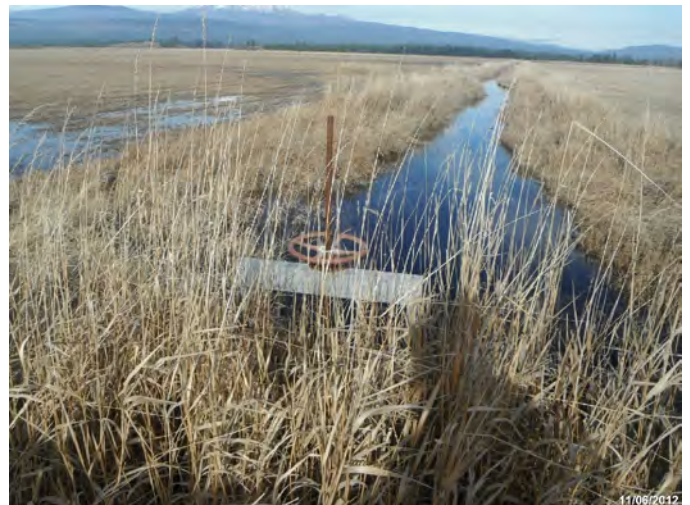
Photo: COLA_C4_0519 Route: 402-004-3.47
Metal WCS Screw Gate 30ft long 24in dia. 3ft deep
Asset# NA

Photo: COLA_C4_0520 Route: 402-004-3.47
Metal WCS Screw Gate 30ft long 24in dia. 3ft deep
Asset# NA

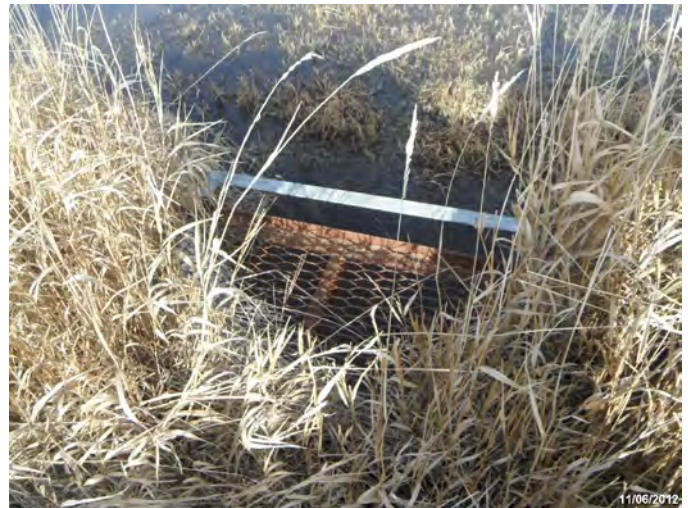
Photo: COLA_C4_0521 Route: 402-004-3.83
Metal WCS Flashboard Riser 30ft long 24in dia. 3ft deep
Asset# NA

Photo: COLA_C4_0522 Route: 402-004-3.83
Metal WCS Flashboard Riser 30ft long 24in dia. 3ft deep
Asset# NA

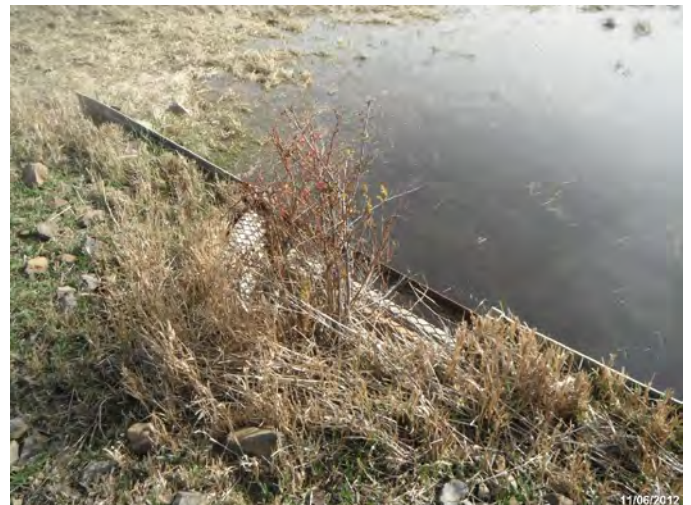
Photo: COLA_C4_0540 Route: 403-001-0.85
Metal WCS Flashboard Riser 25ft long 36in dia. 2ft deep
Asset# NA

Photo: COLA_C4_0541 Route: 403-001-0.85
Metal WCS Flashboard Riser 25ft long 36in dia. 2ft deep
Asset# NA 8-020
